**PRESERVING THE SCHOONER  
*C.A. THAYER***

**MGA J. O. No. 1650**

**Morris Guralnick Associates, Inc.**  
130 Sutter Street, Suite 400  
San Francisco, California 94104-4015  
(415) 362-1242; Fax (415) 362-2619  
10 July 1991  
Revised 9 January 1992

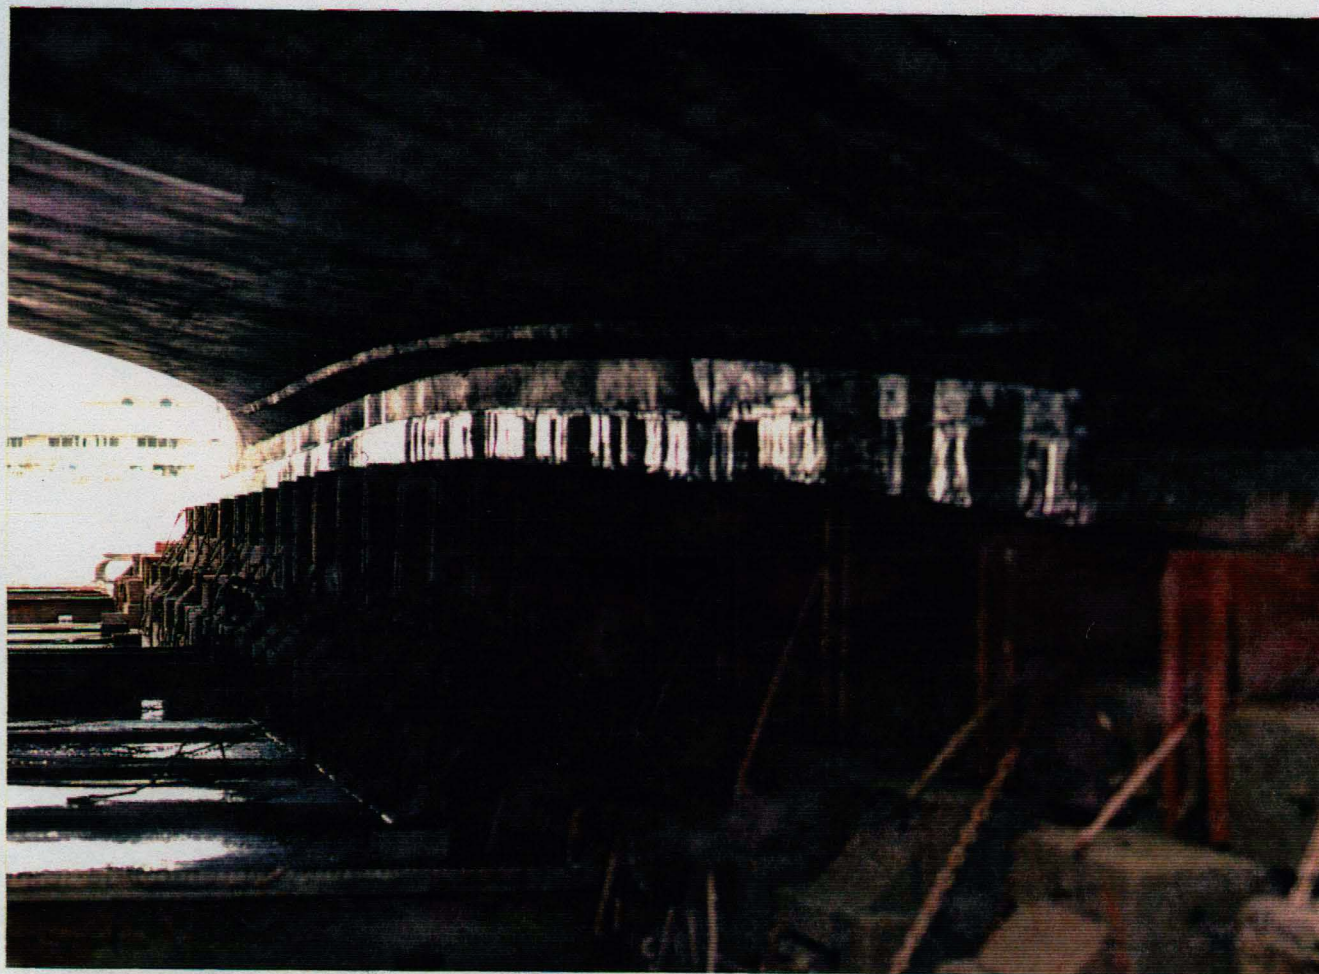
Primarily due to the rotting of wood, the strength of THAYER has declined considerably from what it was in 1892. Nearly a hundred years of rot and decay have made her soft and have weakened the structure to the extent that she cannot be sailed - that much is obvious. What is less apparent is that with every year she is less able to withstand the forces of merely floating in the Aquatic Park. The severe and increasing hog she suffers from is a sign that she is succumbing to these static loads. (A "hog" is the characteristic humped back shape seen on many old wooden ships. The center rises up and the ends droop down - like the profile of a hog.) See photo on Page 14 of C.A. THAYER's hull in drydocking of 22 February 1991.

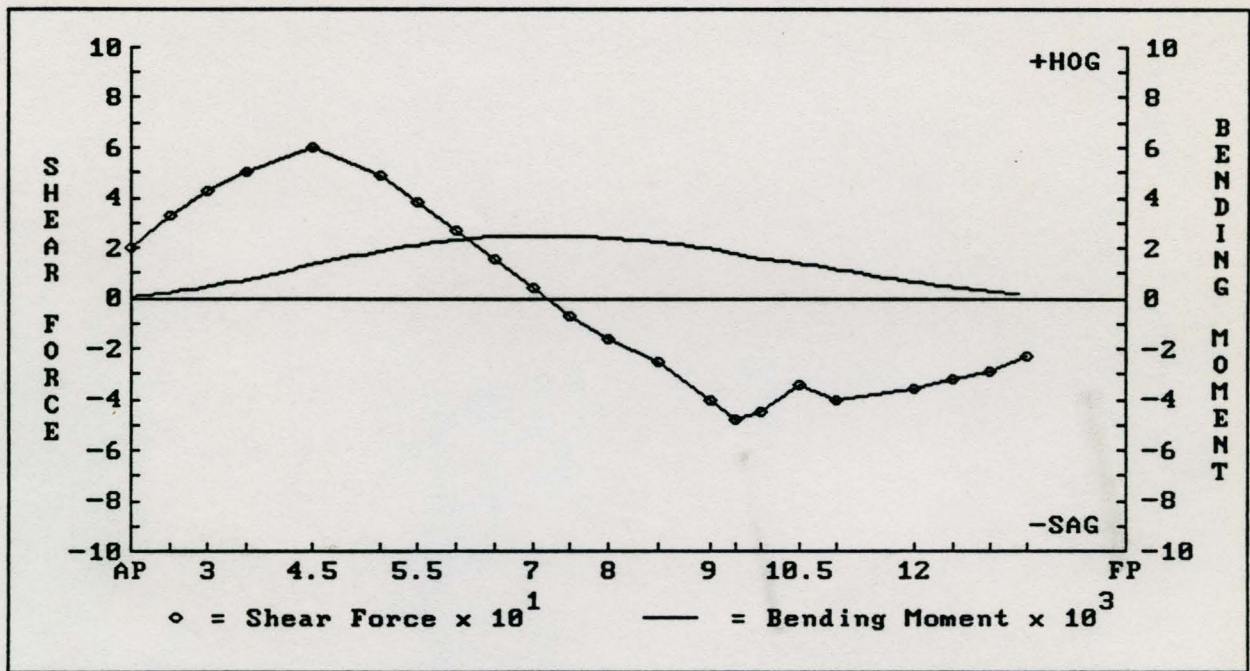
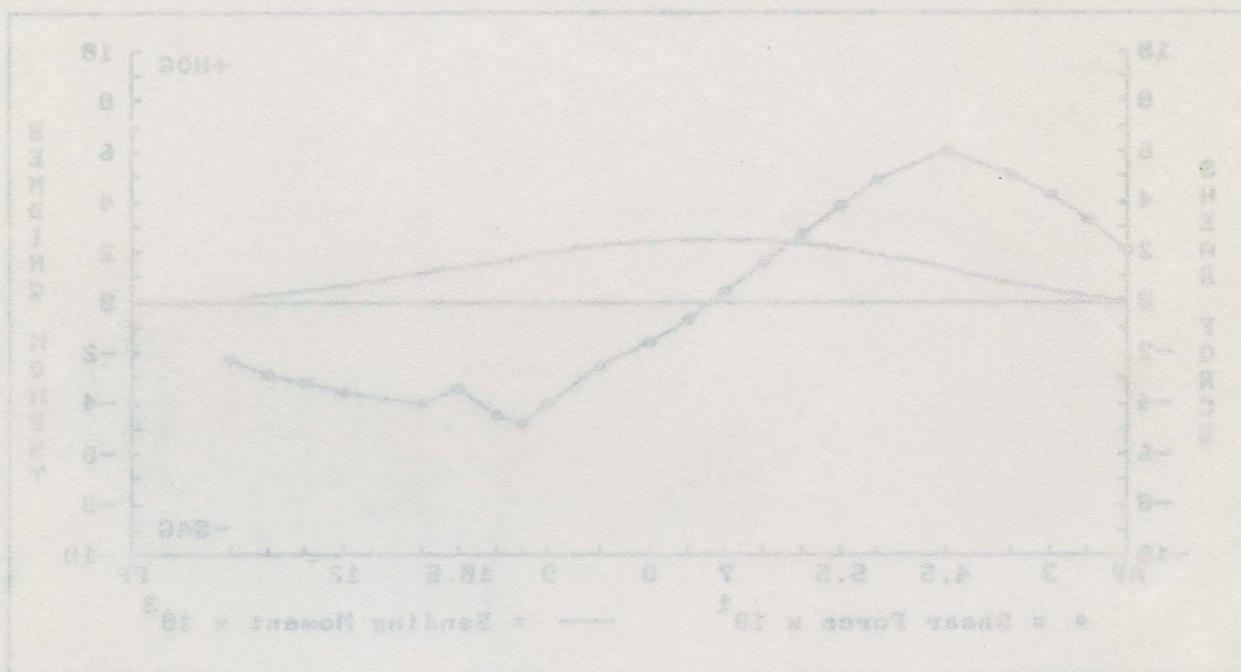
# Present Longitudinal Loading

The longitudinal bending moment is a measure of the forces that are making C.A. WATER hog. It is the smooth solid line of these curves. For the present loading condition (no ballast), the maximum bending moment amidships is about 2500 ft.-tons. The other loading curves show that the bending moment could be reduced or made zero amidships by the addition of ballast or buoyancy. The jagged shear curve shows the change of loading along the length.
